V-1038

PAGING HORN/AMPLIFIER ASSEMBLY

30 WATT -48VDC WITH VOLUME CONTROL

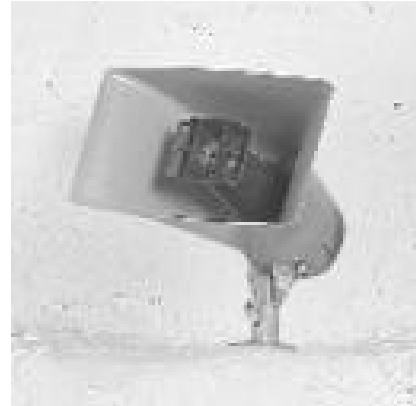
Connections:

Green	Tip	Audio Source
Red	Ring	Audio Source
White	-48VDC	Power
Black	Ground	Power
